A JORDANIAN MODEL IN CONSERVATION OF ARCHITECTURAL HERITAGE

Case Study Dar As Saraya Government Building, Madaba, Jordan

Saqer Mustafa Sqour, Muhannad Tarad

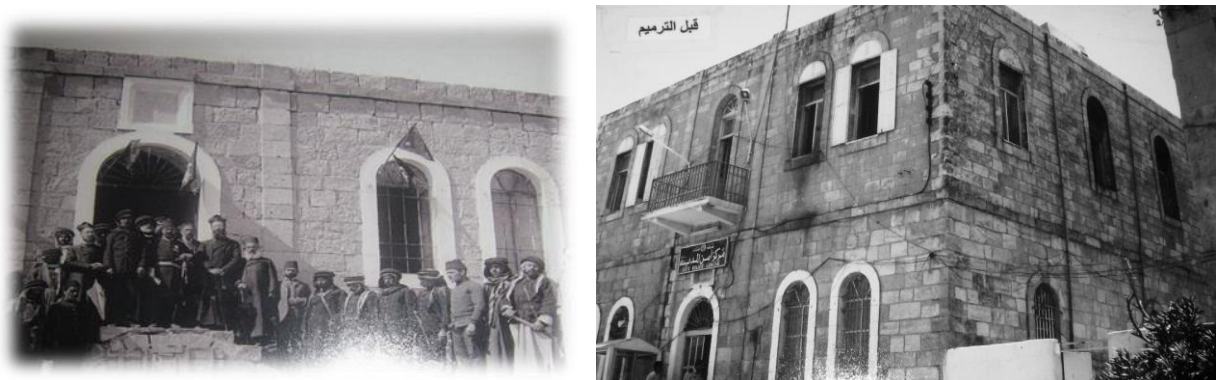
Fig. 2. Dar as Saraya before 1940 s (Left). And after 1946 AD (Right)

In 1922, "*Dar As Saraya*" was used as the building for government departments. And in the 1940s the *British* added the second floor. They used the building as a headquarter for the Magistrate's Court of Madaba until the late seventies of the last century; since then, it was a police station until 2004 AD, in which it became the property of the Ministry of Tourism and Antiquities for its historical importance.

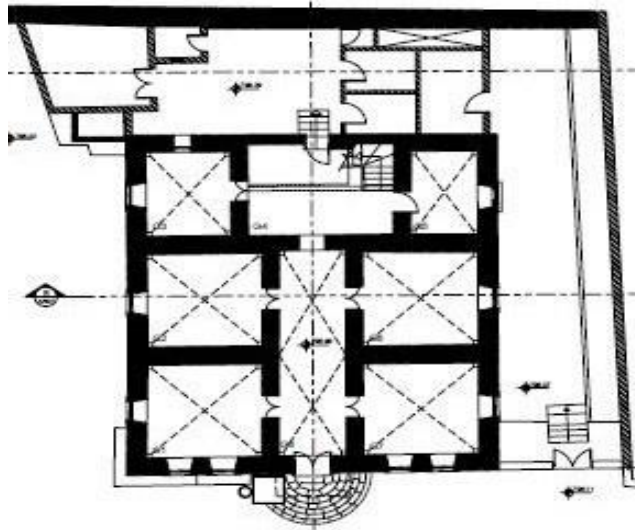
Fig. 3. Ground Floor with the close later addition

1. In 1896 AD the ground floor was built on a high hill. Thus, it views most of the region of Madaba. It formed a series of intersecting vault rooms around the lane heading from North to South, with two entrances ending with an open square.

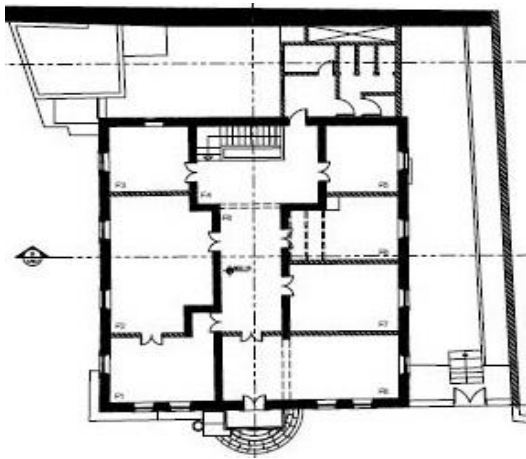
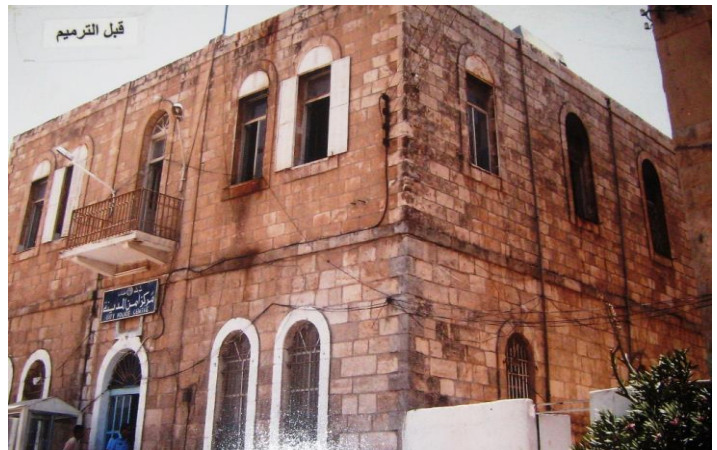
Fig. 4. First Floor with the adjacent later addition

2. The first floor was added after 1946 AD, with load bearing walls.

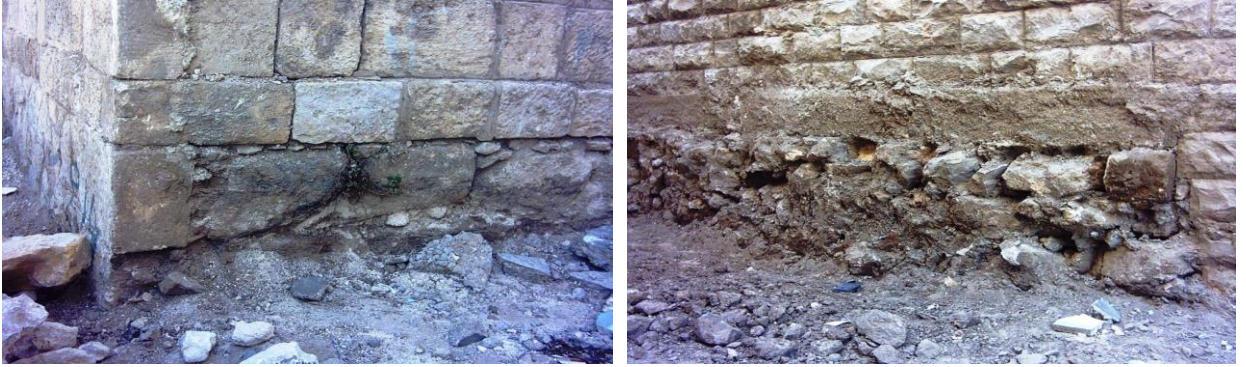
Fig. 5. First maintenance stage

"Dar As Saraya" passed through several stages of maintenance because it suffered from the cracks resulted from rainwater diverting into the foundation. This weakened the foundation. The maintenance included unloading portion of the foundation and put rebar and injected into the bottom of the reinforced concrete walls.

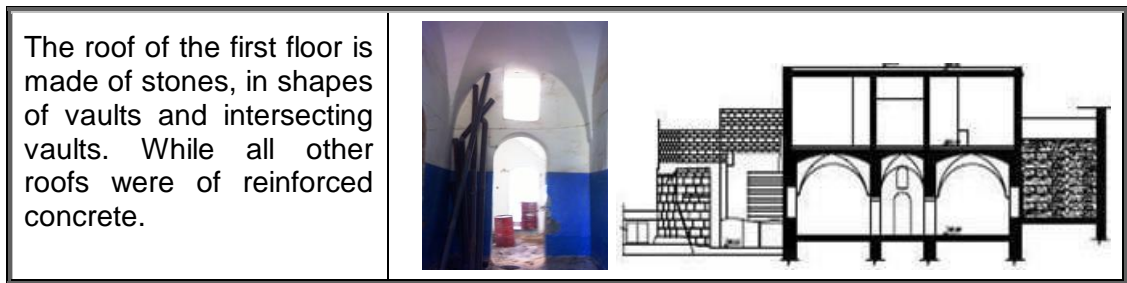
<p>The building was built of carved stone and cement mortar.</p>	
<p>Doors and windows were made of iron and steel as well as the kink protection for windows.</p>	
<p>The interior walls were painted with textured plaster, white and colored paint</p>	
<p>Mud and little stones were used in the intervals between the stones during construction.</p>

Fig. 6. The materials used for constructing the building in its beginning

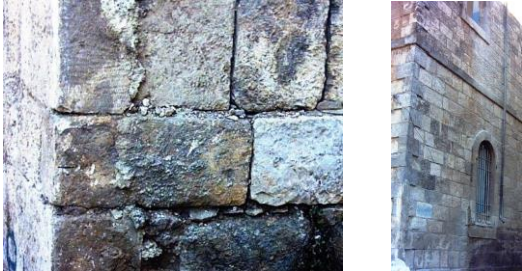
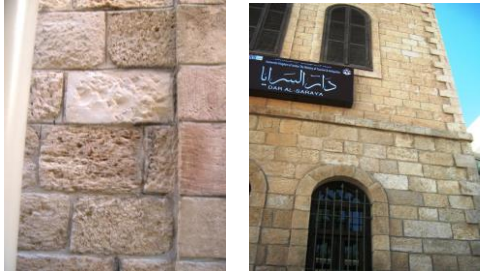
<p>Foundation</p>	<p>Around the damaged foundation they dumped, cleaned the old concrete and replaced it with different reinforcement and tiles.</p>
<p>Foundation Before</p>	<p>Foundation After</p>

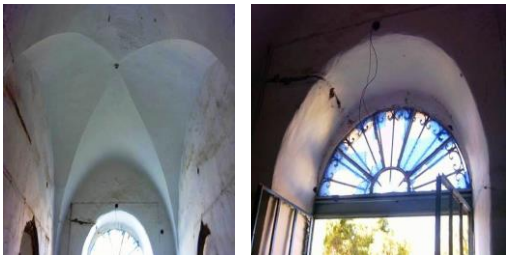
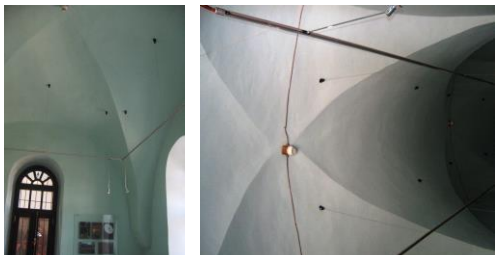
Damaged materials	Damaged materials were replaced with the new ones in the same old-fashioned view. The new materials match the architectural style of the original building.	
Before		After

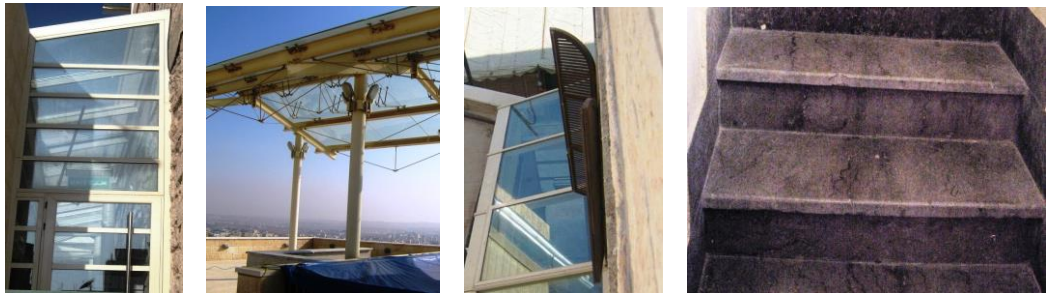
Additions (Arena)	An arena around the building was designed to exploit different activities. The arena was covered with glass to provide proper lighting.

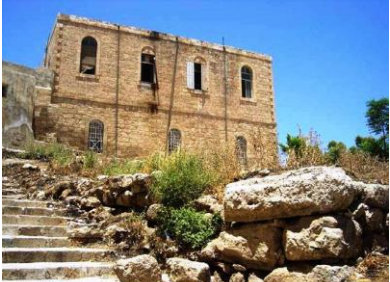
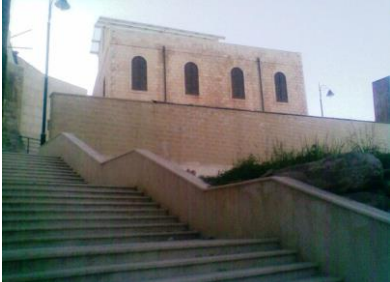
Back elevation & Surroundings		
Before		After

Fig. 8 shows the stages and levels of conservation in the project. It also shows the images of the building before and after the restoration
