PRIMARY DOCUMENTATION AND ARCHITECTURAL ANALYSIS OF THE RURAL HOUSES IN AL-YAZEEDIYEH VILLAGE, AS-SALT, JORDAN¹

Renad Khalil Hamdan

University of Jordan, Amman, Jordan

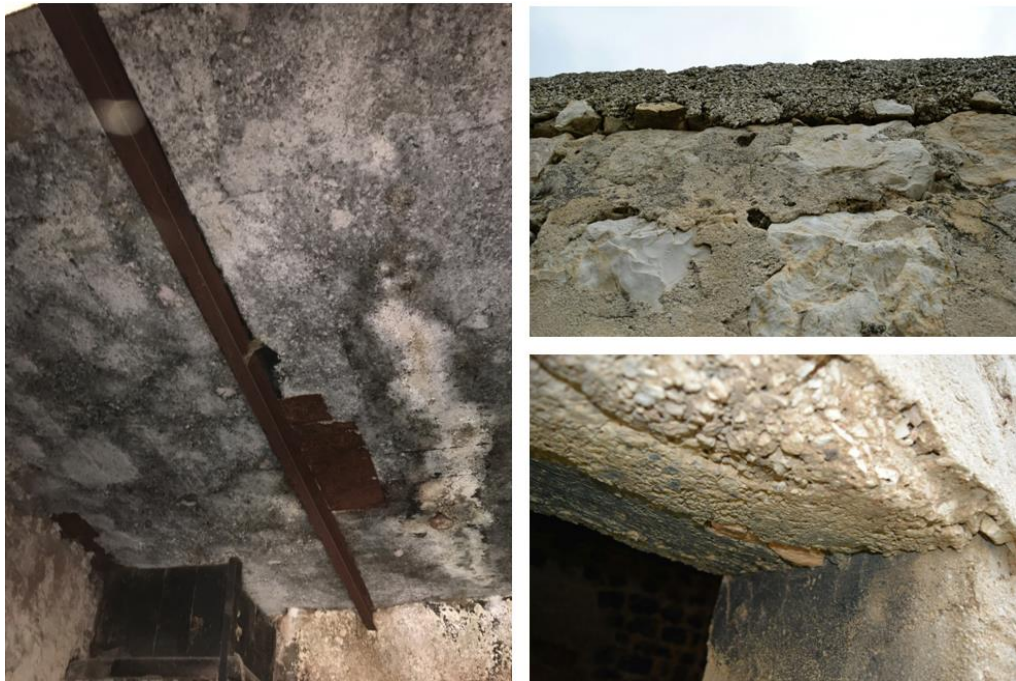
Fig. 2. A ceiling structural system of cement and I beam (Author, 2016)

- Cement and I beam system (Fig. 2).
- Repeated arch system (Fig. 3).

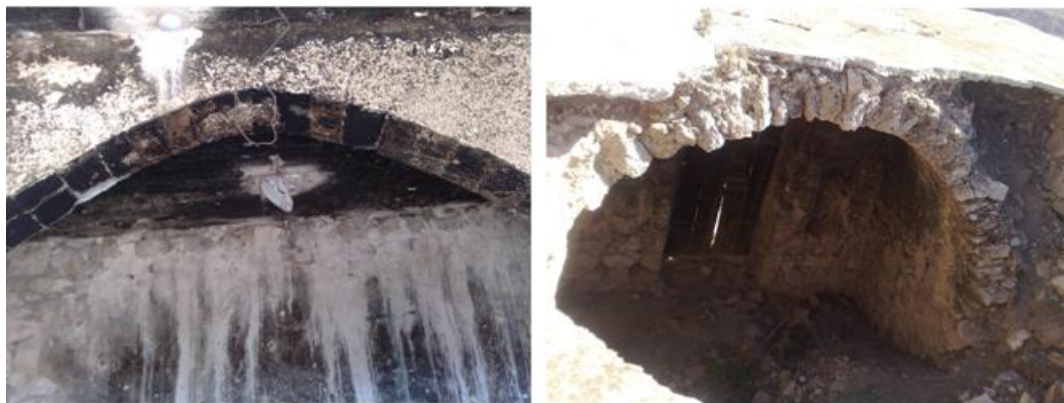
Fig. 3. Structural Arches support the ceilings, the pictures are for house No. 1 Block 1 (right) and house No. 3 Block 3 (left) (Author, 2016)

Its architecture, like most of the Jordanian highland, was built with stone, forming simple rectangular geometry with internal arches, in some houses, made to outspread large spans and support ceilings. The condition of these houses in general is good for walls, roofs and openings. The floors suffering from the dirtiness of livestock life. Some of the missing parts like doors found on the site.

The most common type of structure in the Transjordanian rural house was the repeated arch structure.

Stone was used to build the walls of a simple rectangular house and the ceiling was constructed by using two different structural systems; interior repeated arches structure as found in house No. 1 Block 1, and I beams with cement to achieve a flat stable roof as found in most of the houses.

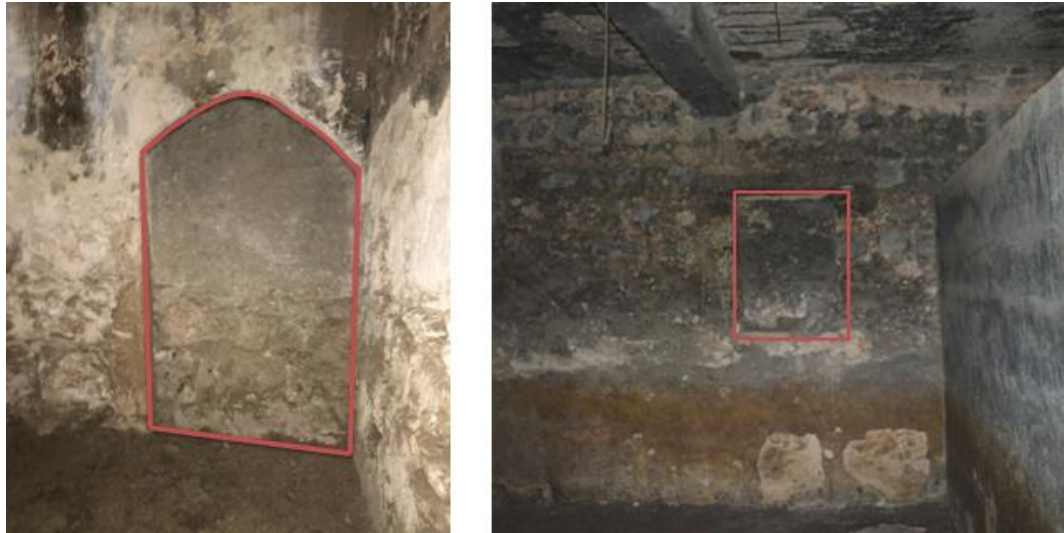
Fig. 4. The large size of *matwa* (left) and the small size of it (right) inside house (Author, 2016)

- *Matwa*: it is cabinet for storing woven items. There are two size founded; large *matwa* is used for storing bedding; small *matwa* is used for storing household items such as clothes (Fig. 4).
- *Kawayer*: are storage facilities made from clay or wood and used to preserve grain (Khammash, 1986) (Fig. 5).

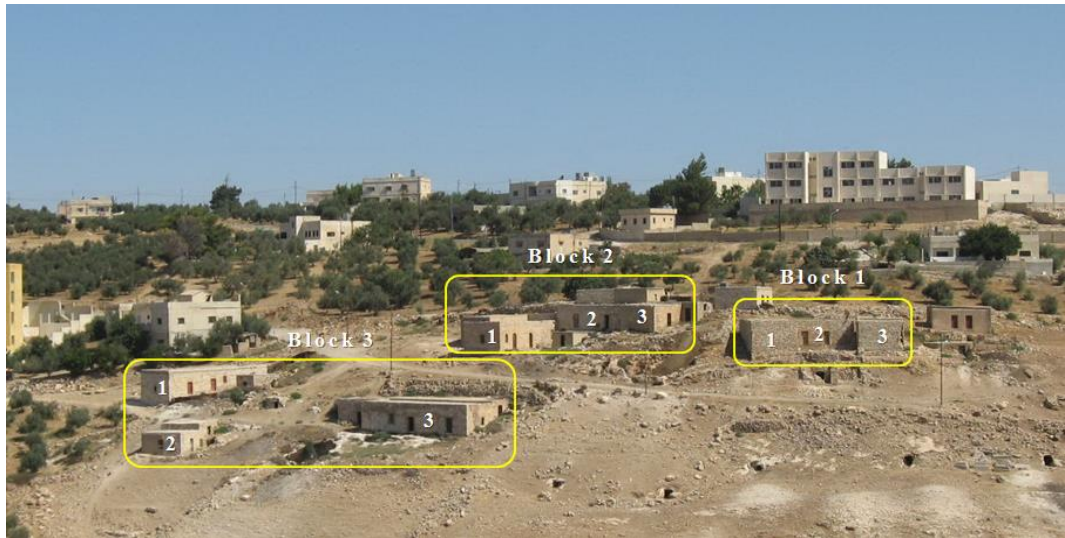
Fig. 6. Al Yazeediyeh rural houses, Block 1, Block 2, Block 3 (Author, 2016)

In this research, the houses were divided into three blocks depending on the clustering of houses with one front yard: Block 1, Block 2, and Block 3 (Fig. 6).

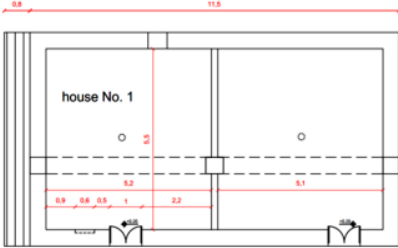
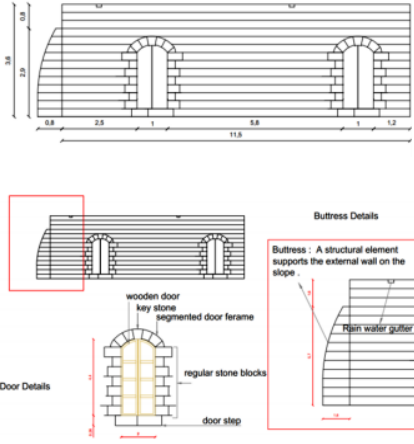
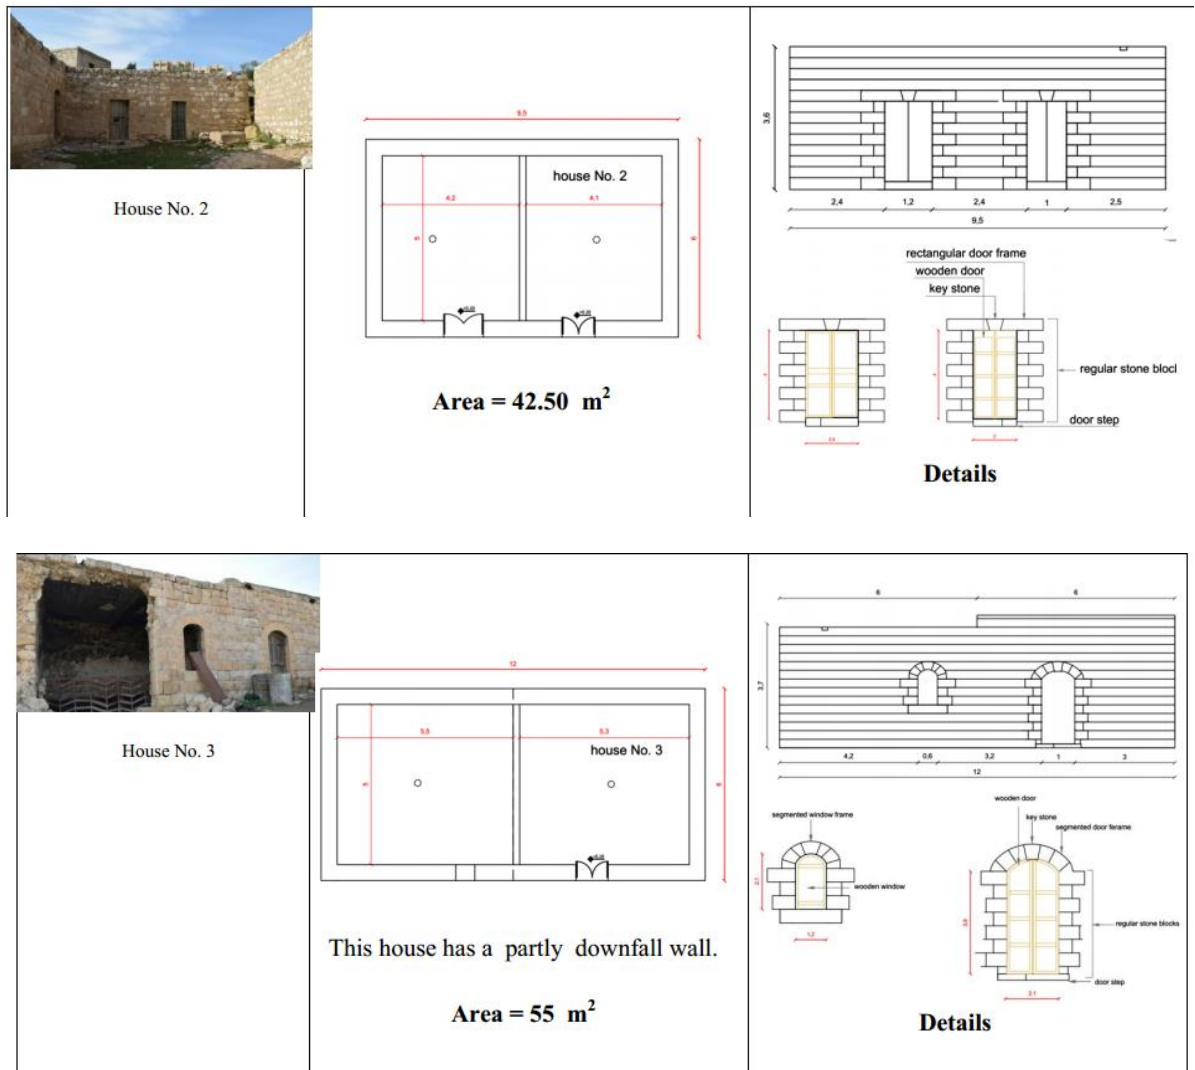
<p>House No. 1</p>

ARCHITECTURAL ELEMENT(Block 1)	CEILINGS	WALLS	OPENINGS	FLOORS
CONDITION AND DESCRIPTION DAMAGE	Good condition except house No. 1 has a partly downfall close to the interior arch.	Good condition except the house No. 3 has a partly downfall wall.	The doors and window shutters are exits on their places or lying on the ground.	Good condition made of mud.

<p>This house has a butress as special structural element to support the external wall on the slope.</p> <p>Area = 57.75 m²</p>

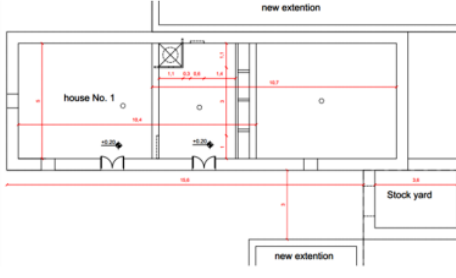
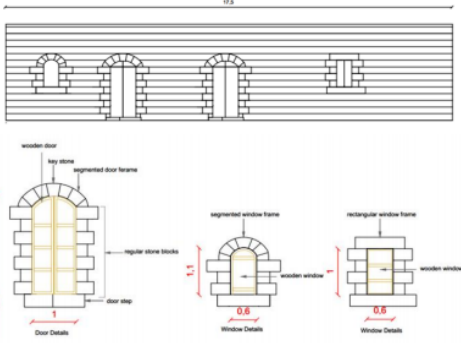
<p>House No. 1</p>

ARCHITECTURAL ELEMENT (Block 2)	CIELINGS	WALLS	OPENINGS	FLOORS
CONDITION AND DESCRIPTION DAMAGE	Good condition.	Good condition except house No.3 has a falling of external wall.	The doors and window shutters are exit on their places.	Good condition made of mud.

<p>Area = 82.50 m²</p>

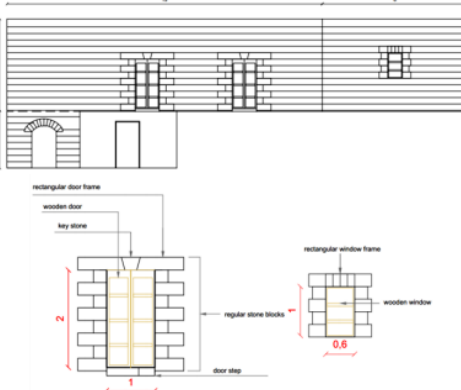
<p>House No. 2, House No. 3</p>	<p>House No. 2 and House No. 3 are attached and it rising from the first level of house No.1 by 2.30 m.</p>

<p>Area = 94.20 m²</p>

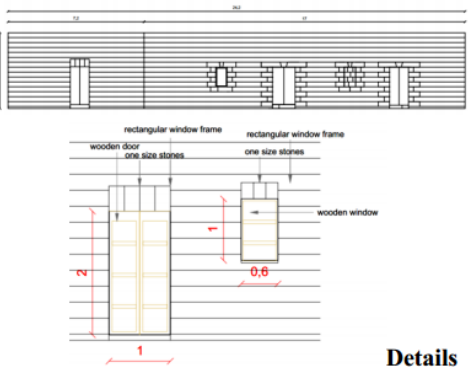
<p>House No. 1</p>

ARCHITECTURAL ELEMENT (Block 3)	CIELINGS	WALLS	OPENINGS	FLOORS
CONDITION AND DESCRIPTION DAMAGE	Good condition.	Good condition.	The doors a window shutters are on their places except house No.3 two doors shutters are missing.	Good condition made of mud.

<p>Area = 106 m²</p>

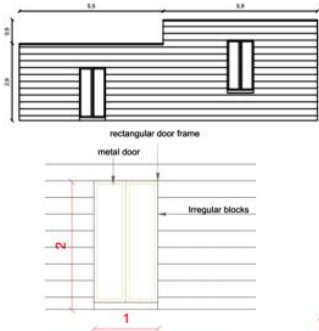
<p>House No. 2</p>

<p>Area = 53 m²</p>

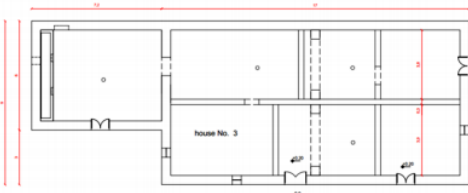
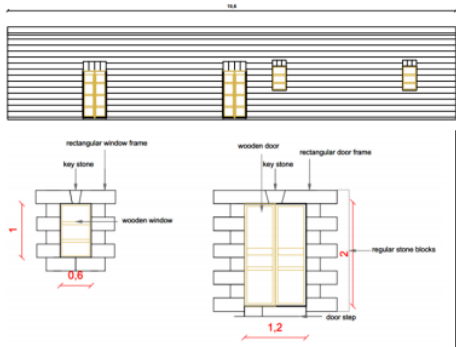
<p>House No. 3</p>

<p>Area = 164 m²</p>
